Inspection report

Road: KILVAXTER DRIVE	Division:	start MH: S.2
Place: DARNLEY	District:	end MH: S.1
Location: Light road	Tape No.: 001	Total length: 14.3 m

Purpose: Renovation works	Size/Shape: Circular 150
Use: Surface water	Material: Polyvinyl chloride Pipe length:
Catchment:	Lining:
	Category:

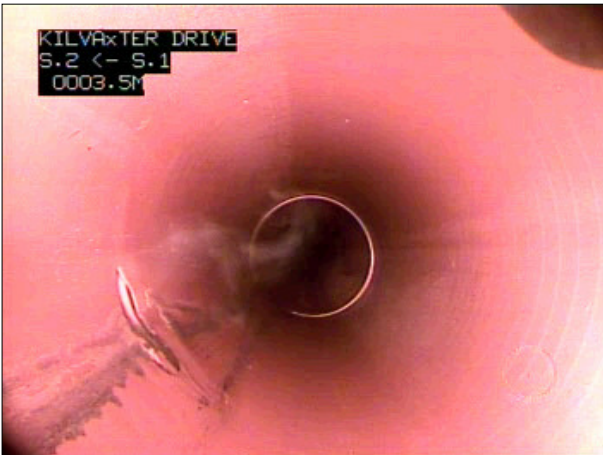
Photo: 17_6a, Tape No.: 001, 00:01:39
3.5m, Hole in sewer from 06 to 07 o'clock

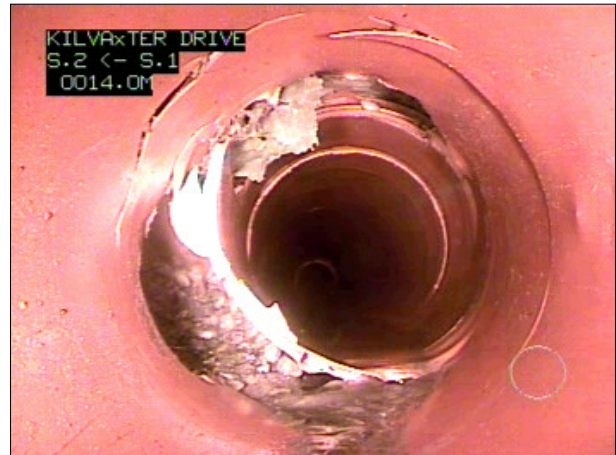
Photo: 19_8a, Tape No.: 001, 00:04:32
14m, Circumferential Fracture, from 09 to 04 o'clock

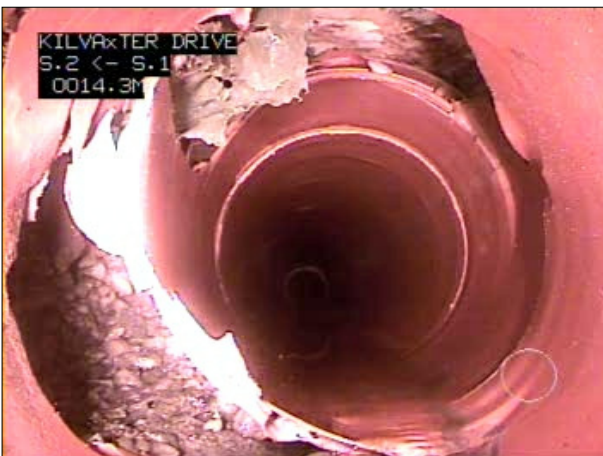
Photo: 20_9a, Tape No.: 001, 00:05:22
14.2m, Hole in sewer from 06 to 09 o'clock
